WILLS

**Re: Revised Slope Assessment and Setback Requirements to Support the Application of Official Plan and Zoning By-law Amendments
Lovesick Lake Beach Resort
3340 Strickers Lane, Selwyn, Ontario
D.M. Wills Project No. 18-10844**

Appendix B – Site Investigation Photographic Log

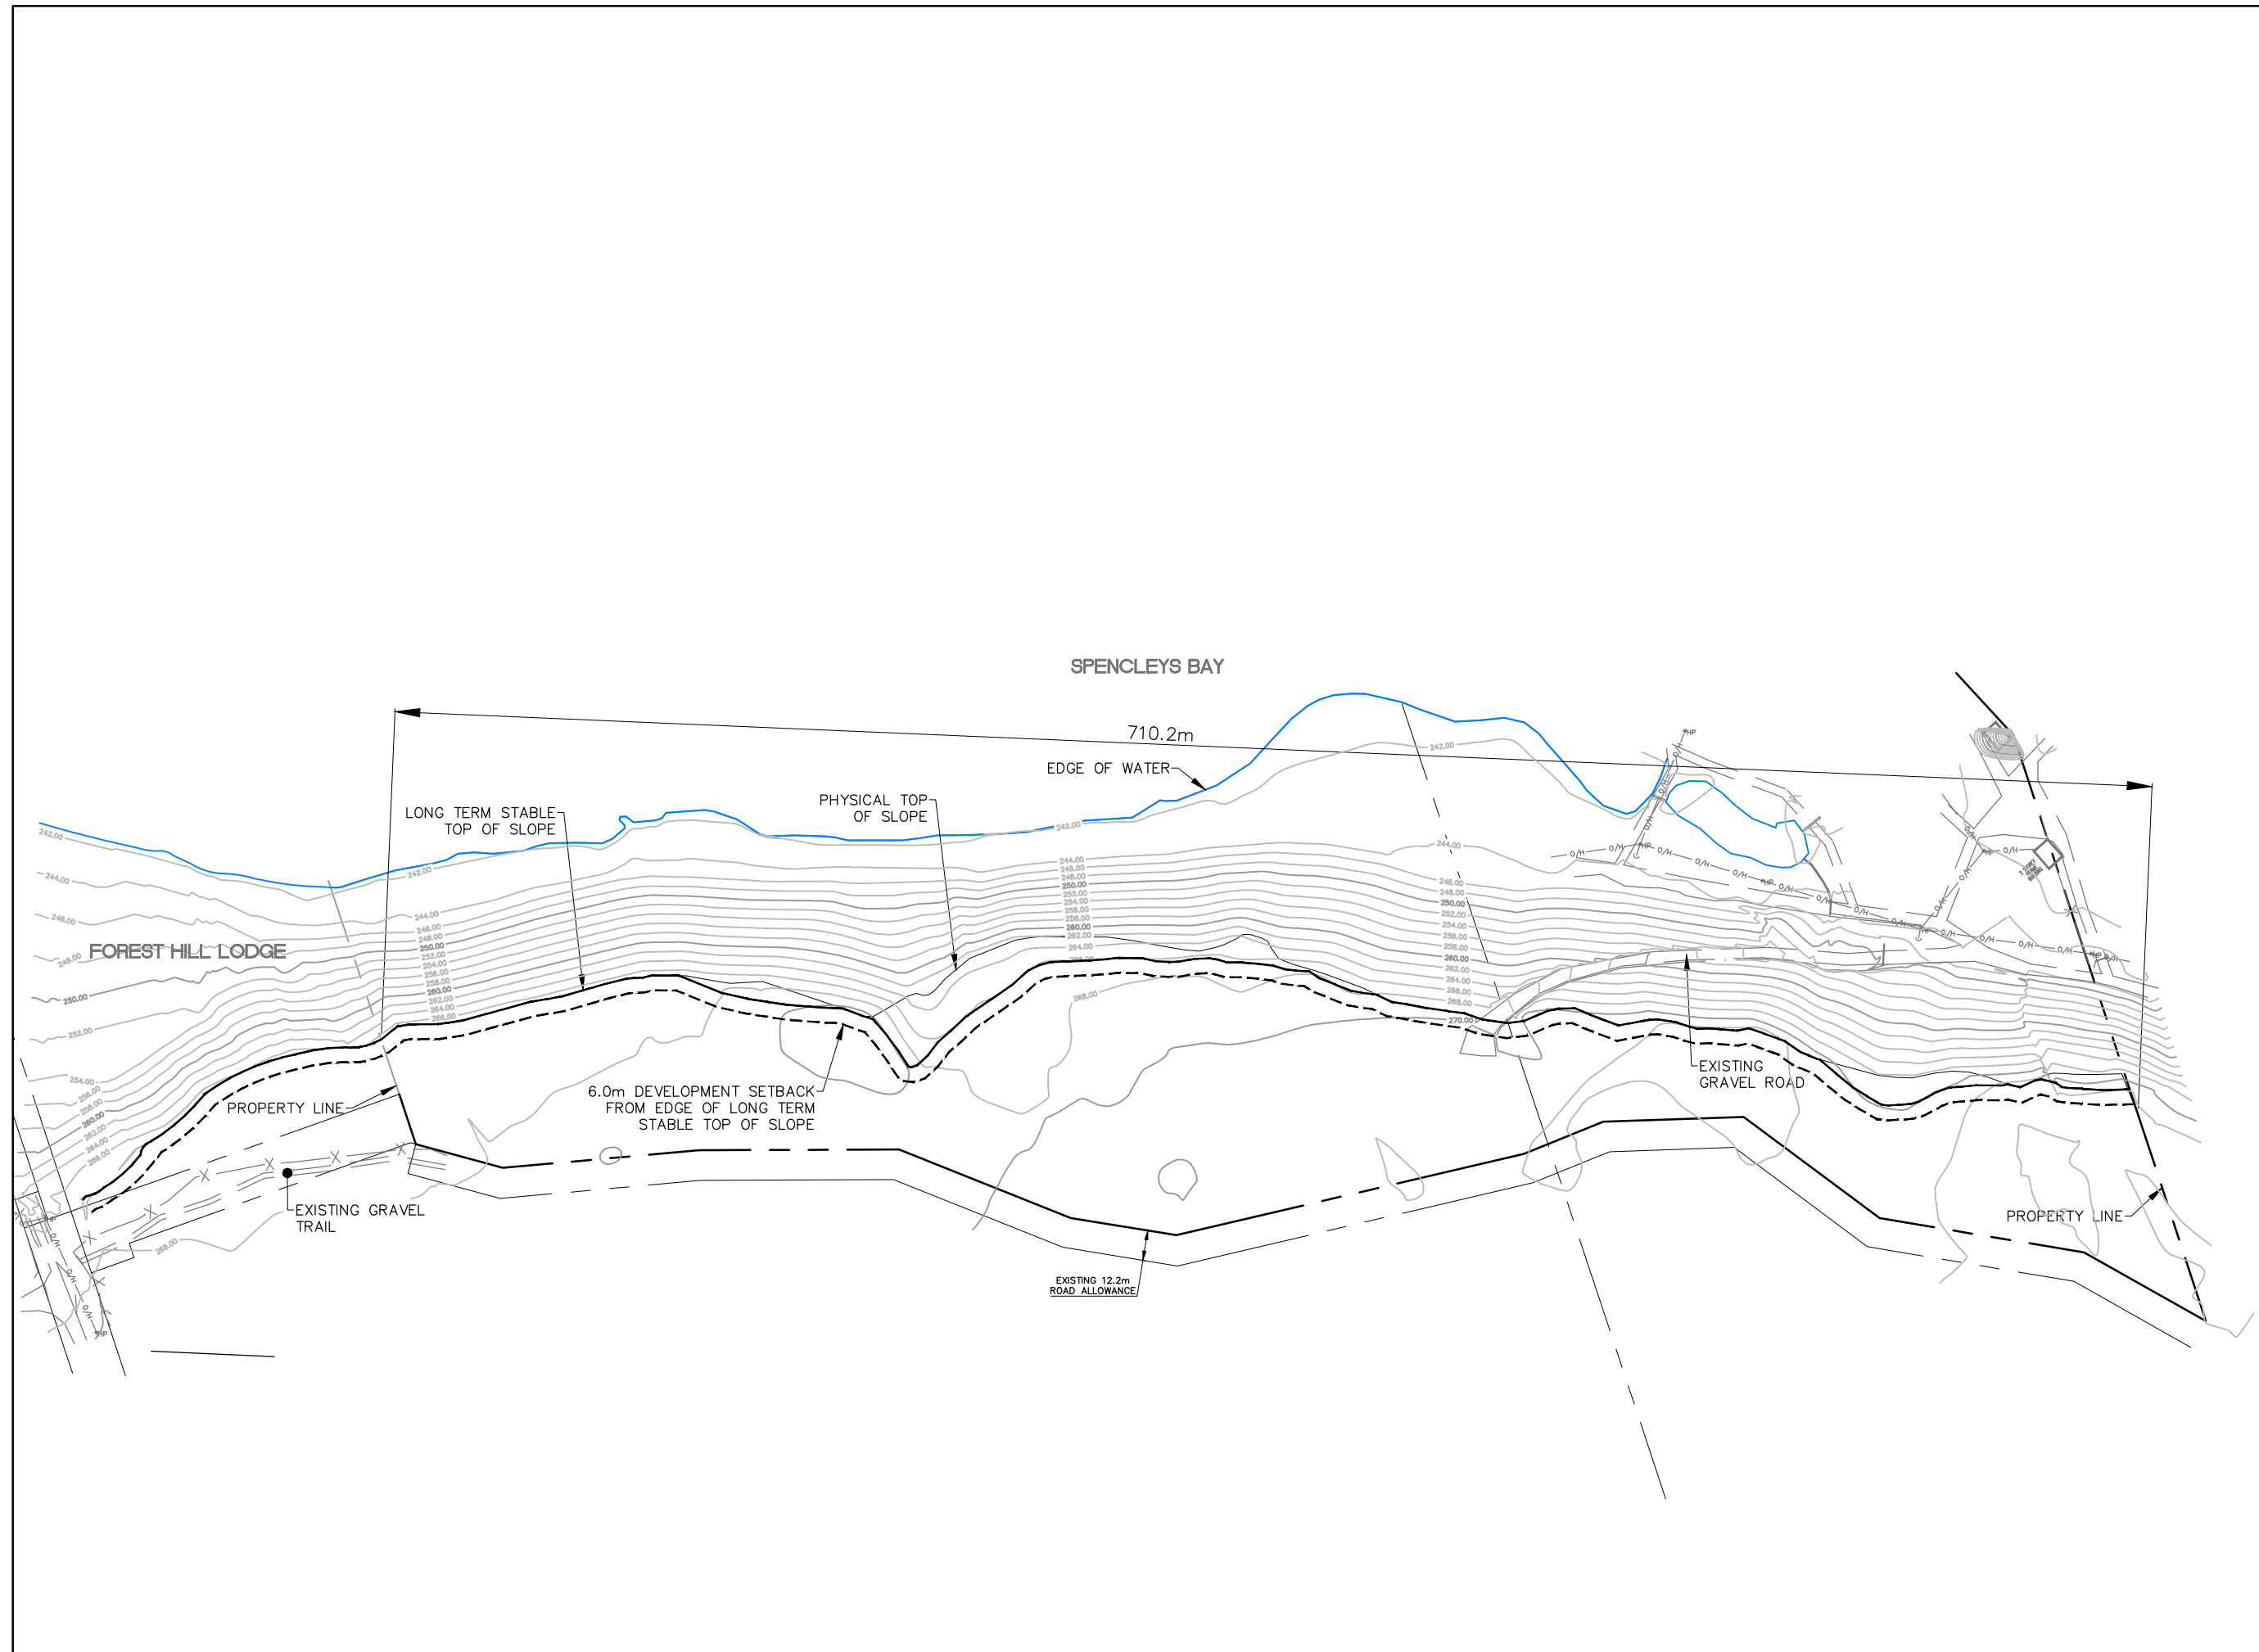
Drawing Title
SLOPE STABILITY AND SETBACK PLAN

Because the inclination of Subject Slope is flatter than the recommended 1H:1V stability gradient, the stability gradient does not intersect the Subject Slope and is observed to extend above the slope face. As a result, the physical top of slope, as determined during the Elliott and Parr Ltd survey, was used to represent the stability setback component and is considered conservative. The physical top of slope is shown on the Slope Stability and Setback Plan in **Appendix A**.

For the purpose of the Proposed Development, a 6 m development setback was determined suitable and was applied from the LTSTOS limit determined by Wills. This 6 m development setback is shown on the Slope Stability and Setback Plan in **Appendix A**.

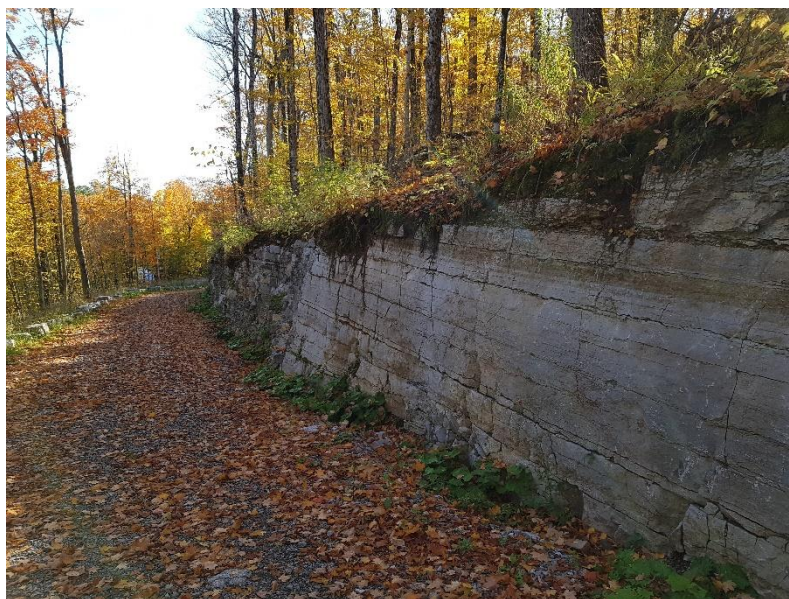
Photograph No.: 1

Exposed calcareous bedrock was observed along the top of the escarpment, along the south face of the road cut and intermittently along the slope face and toe of slope area. The buff to light grey coloured calcareous bedrock was observed to have horizontal bedding and can be described as thin (0.03 m to 0.1 m) to thick (0.3 m to 1.0 m). Bedrock exposure along the road cut is shown on Photographs No.1 and No.2 in **Appendix B**.

Exposed limestone / dolostone bedrock on south side of road cut.

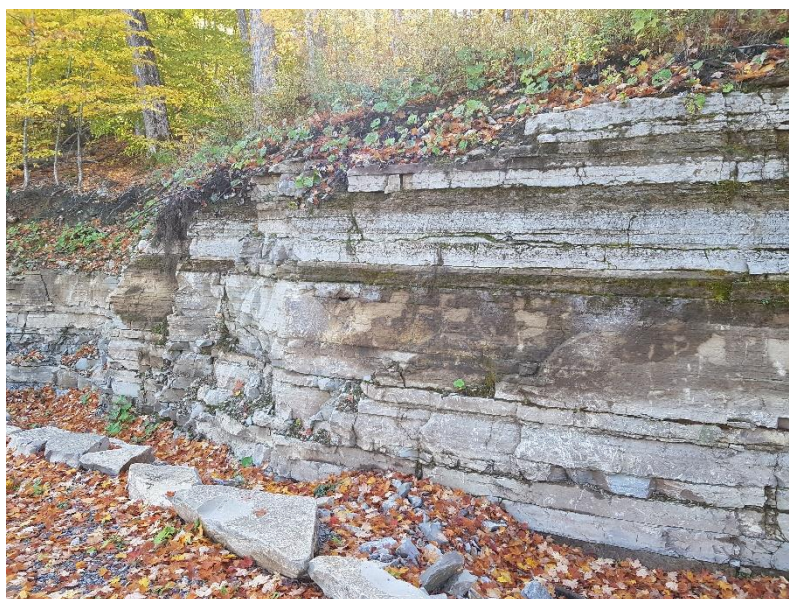
Photograph No.: 2

Exposed limestone / dolostone bedrock on south side of road cut.

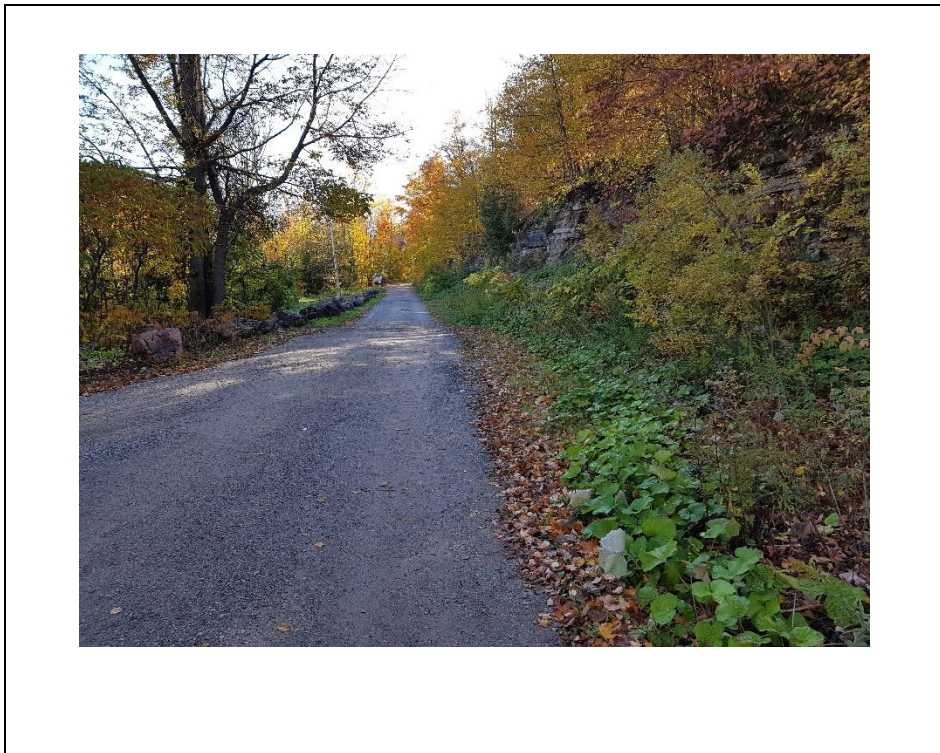
The toe of slope was accessed by a narrow gravel roadway that extends west from Strickers Lane towards Forest Hill Road, parallel to the toe of slope. The gravel roadway is separated from Lovesick Lake by a narrow strip of land that maintained trailer sites at the time of the slope inspection. The toe of slope and gravel roadway are shown on Photographs No. 3 and No. 4 in **Appendix B**.

Photograph No.: 3
Date: October 15, 2019
Direction: East
Description: Gravel roadway adjacent to toe of slope. Vegetated toe of slope and exposed bedrock visible on right side of photograph.

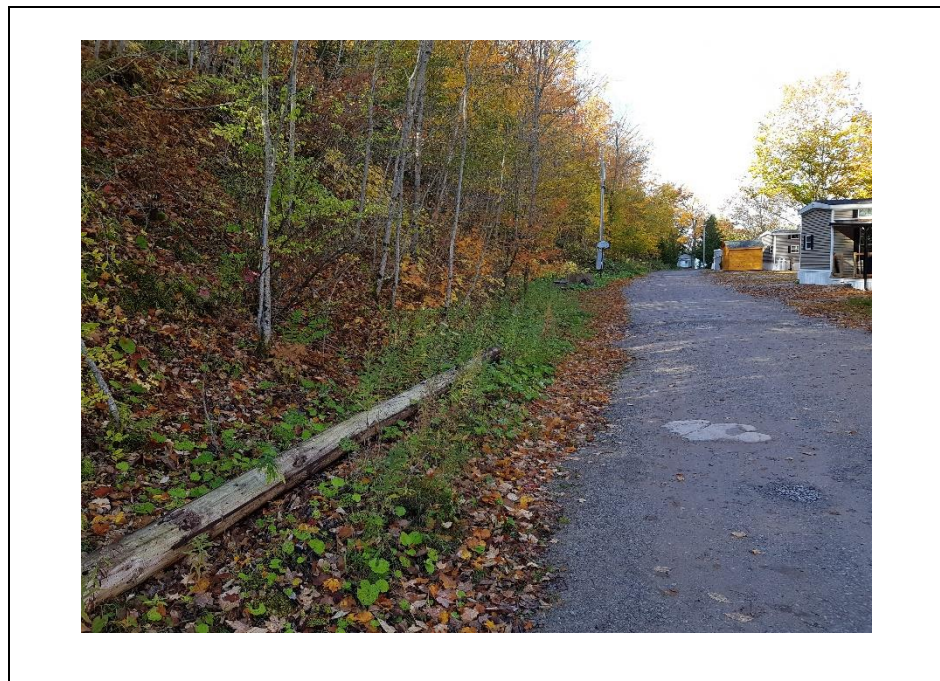
Photograph No.: 4
Date: October 15, 2019
Direction: West
Description: Gravel roadway adjacent to toe of slope. Vegetated toe of slope visible on left side of photograph.

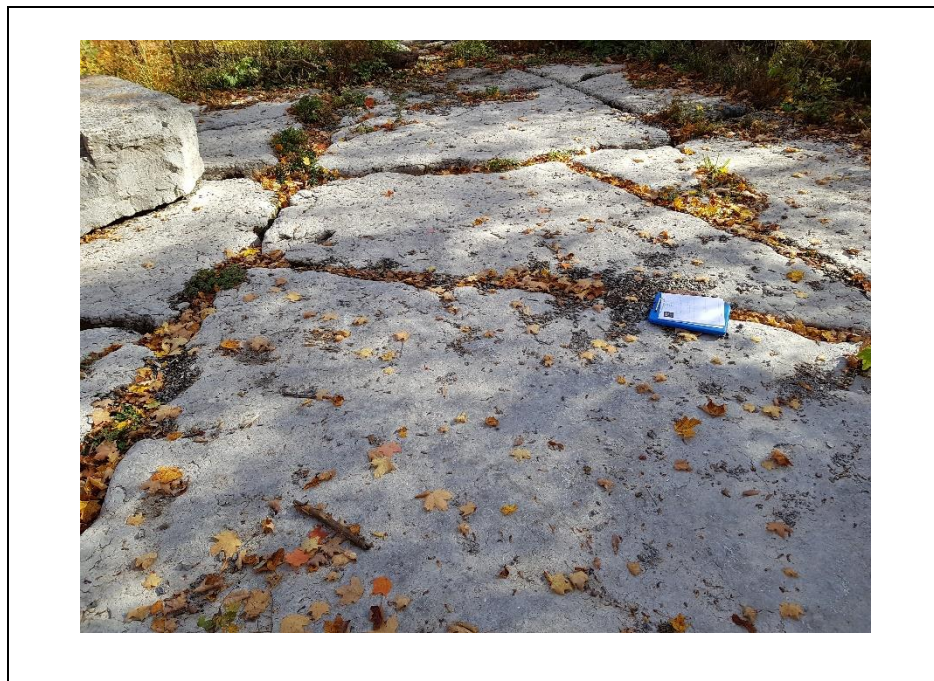
A joint (fracture) system comprising generally NE-SW and NW-SE oriented joint sets was observed in exposed bedrock along the top of the escarpment. Joint sets were near vertical, spaced approximately 0.5 m to > 2.0 m apart and showed preferential weathering at surface. Based on observations made along the exposed bedrock faces, the joint sets are vertically discontinuous and do not fully penetrate the various sedimentary beds. The massive to blocky rock mass conditions of the exposed bedrock is shown on Photographs No. 5 and No. 6 in **Appendix B**.

Photograph No.: 5
Date: October 15, 2019
Direction: East
Description: Massive to blocky limestone / dolostone bedrock. NE / NW jointing visible. Top of escarpment, east side.

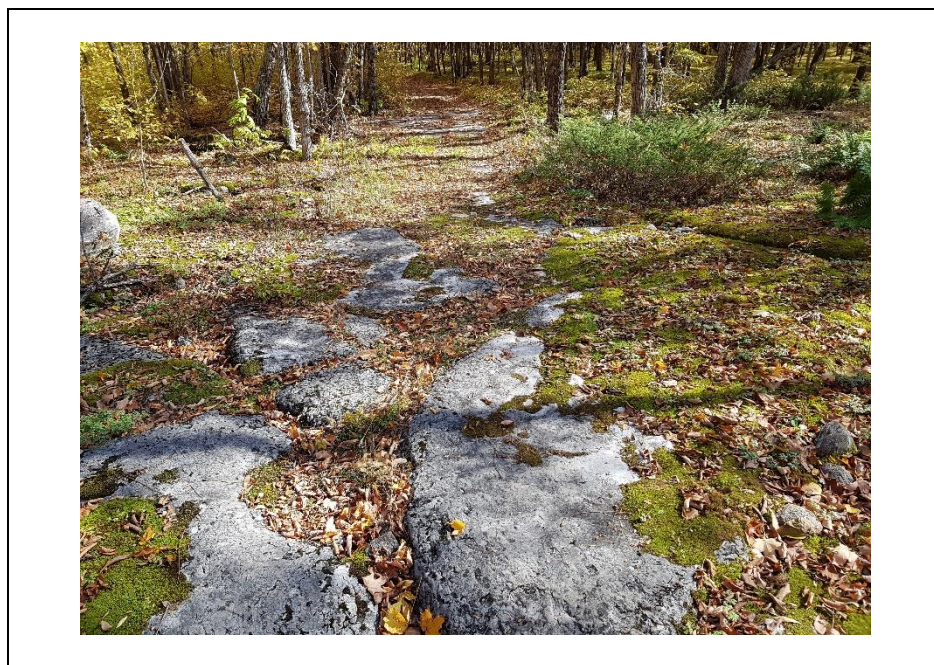
Photograph No.: 6
Date: October 15, 2019
Direction: East
Description: Exposed Massive to blocky limestone / dolostone bedrock. Top of escarpment, central area.

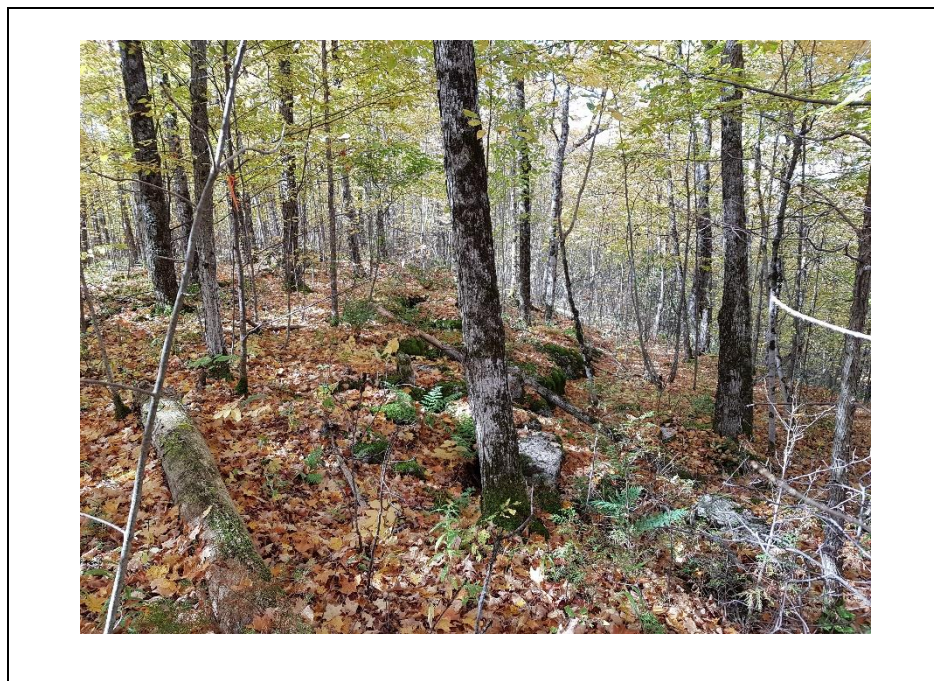
During the slope inspection, minor bedrock irregularities and locally steep bedrock exposures were observed directly above the physical top of slope. Wills determined that these irregularities constitute localized slope hazards and should be captured by the LTSTOS limit, as shown on the Slope Stability and Setback Plan in **Appendix A**. An example of these bedrock irregularities above the physical top of slope are shown on Photograph No. 7 in **Appendix B**.

Photograph No.: 7
Date: October 15, 2019
Direction: West
Description: Exposed limestone / dolostone bedrock along escarpment slope crest. Irregular bedrock topography above physical top of slope.

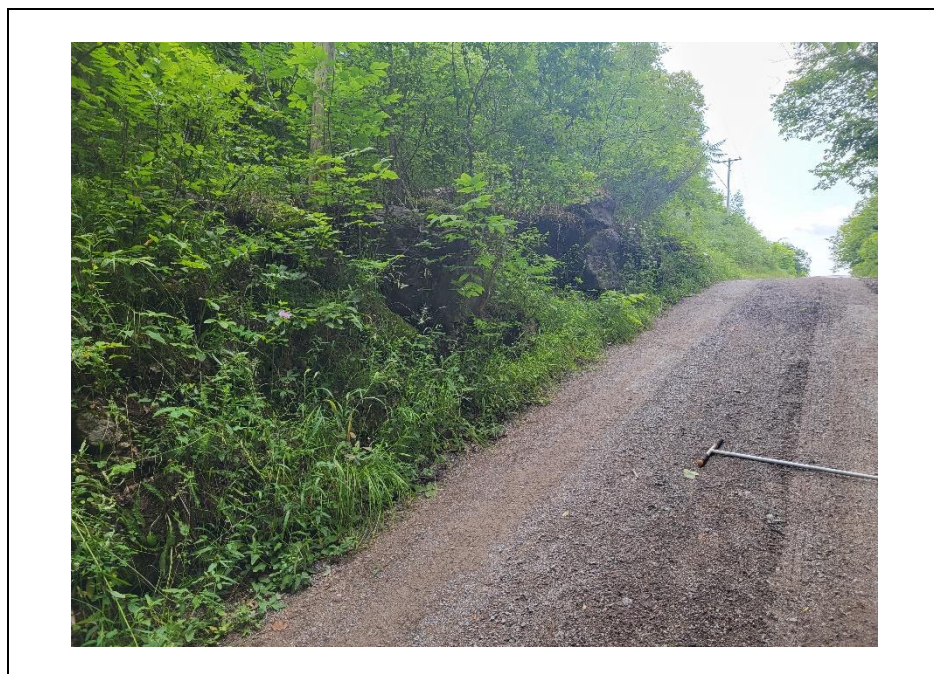
Photograph No.: 8
Date: July 18, 2023
Direction: East / Southeast
Description: Exposed limestone / dolostone bedrock along the east side of Forest Hill Rd extension to the north.

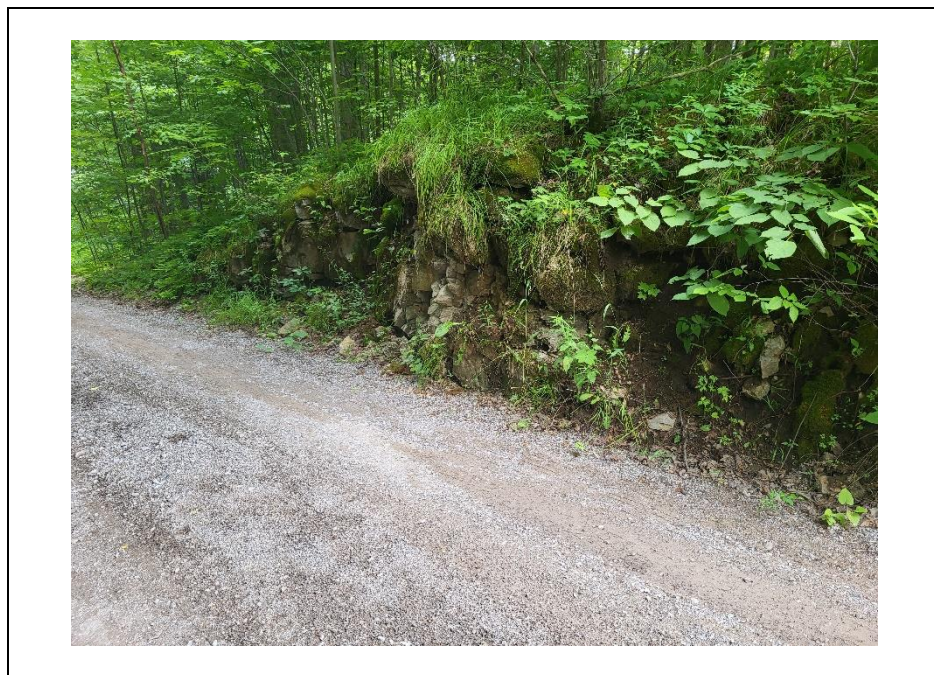
Photograph No.: 9
Date: July 18, 2023
Direction: East / Northeast
Description: Exposed limestone / dolostone bedrock along the east side of Forest Hill Rd private extension to the north.

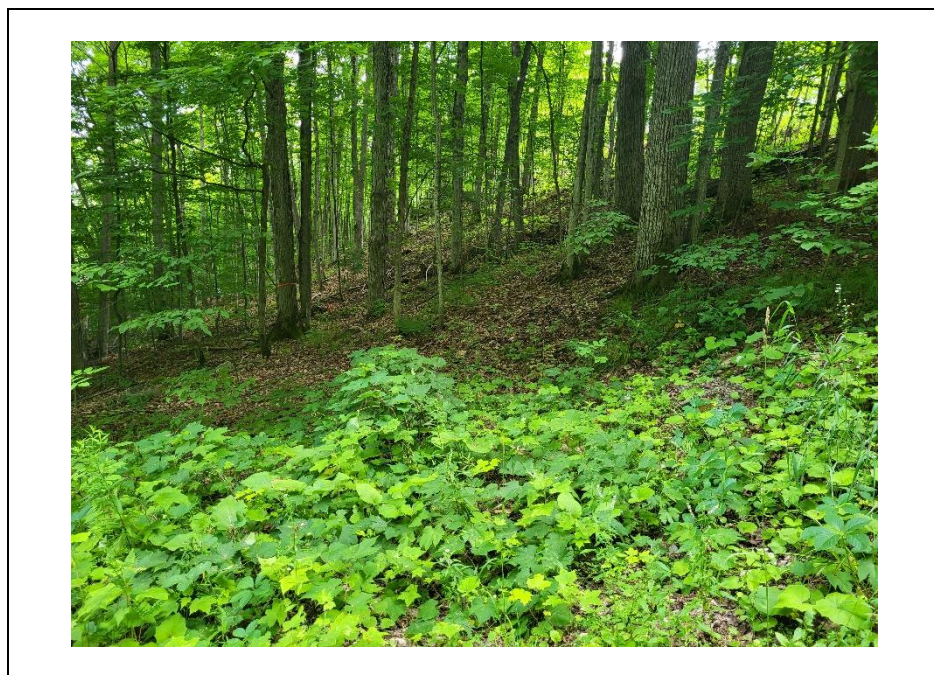
Wills completed a second site visit on July 18, 2023, to assess the stability of the section of the slope located between the western limit of the Subject Property and Forest Hill Road. Photographs captured during that second visit are included as Photographs No. 8 to No. 11 in **Appendix C**. Wills findings have been included in the present Slope Assessment, in particular on the Slope Stability and Setback Plan provided in **Appendix A**.

Photograph No.: 10
Date: July 18, 2023
Direction: East
Description: Vegetated slope between the western property line and Forest Hill Rd.

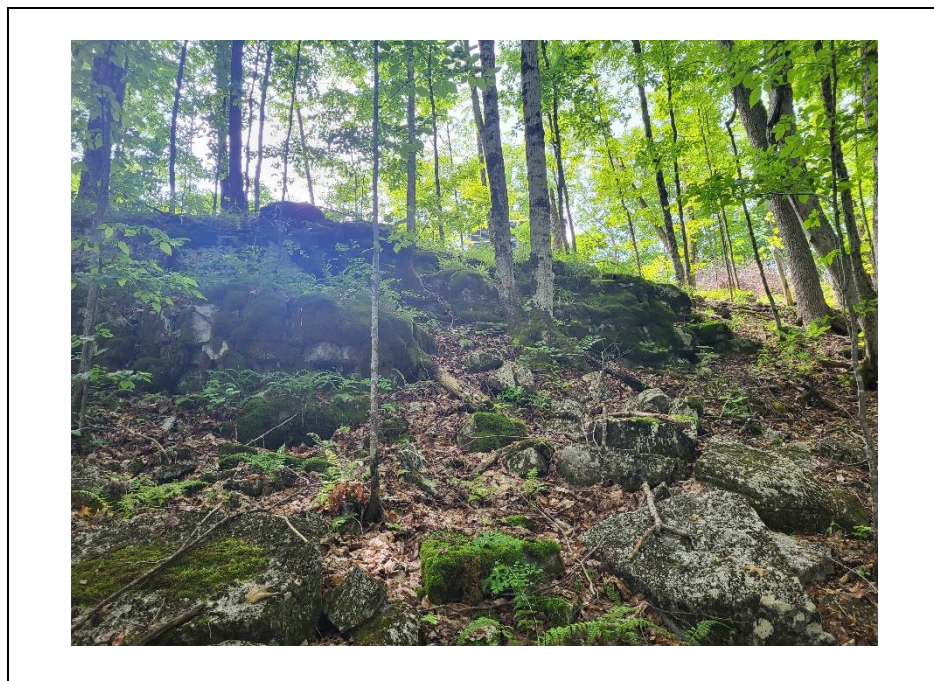
Photograph No.: 11
Date: July 18, 2023
Direction: South
Description: Exposed limestone / dolostone bedrock along escarpment slope crest between the western property line and Forest Hill Rd.
