2022

Asset Management Plan

Township of Selwyn

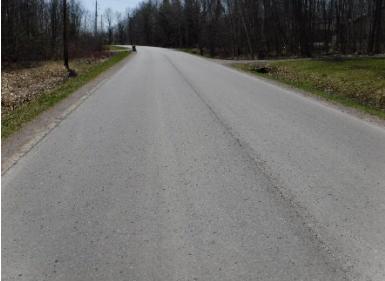
90 - 100	<p>Pavement is in excellent condition with few cracks. The Ride Condition Rating is excellent with few areas of very slight to slight distortion.</p>

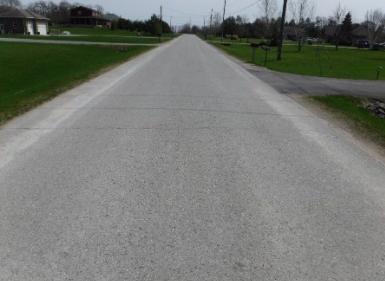
75 - 90	<p>The pavement is in good condition with frequent very slight or slight cracking. The Ride Condition Rating is good with a few slightly rough and uneven sections.</p>

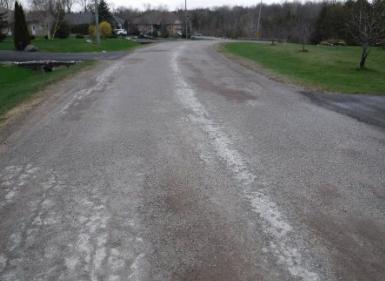
65 - 75	<p>The pavement is in fairly good condition with slight cracking, slight or very slight distortion and a few areas of slight alligatoring. The Ride Condition Rating is fairly good with intermittent rough and uneven sections.</p>

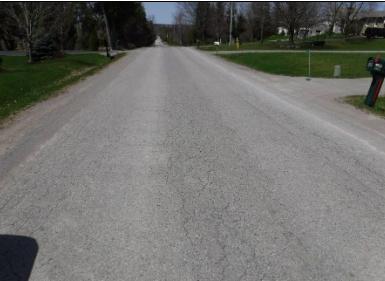
50 - 65	<p>The pavement is in fair condition with intermittent moderate and frequent slight cracking, and with intermittent slight or moderate alligatoring and distortion. The Ride Condition Rating is fair and the surface is slightly rough and uneven.</p>

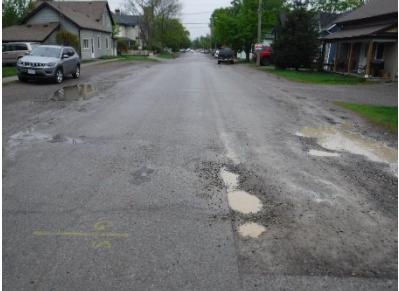
40 - 50	<p>The pavement is in poor to fair condition with frequent moderate cracking and distortion, and intermittent moderate alligatoring.</p> <p>The Ride Condition Rating is poor to fair and the surface is moderately rough and uneven.</p>
N/A	30 - 40	<p>The pavement is in poor to fair condition with frequent moderate alligatoring and extensive moderate cracking and distortion.</p> <p>The Ride Condition Rating is poor to fair and the surface is moderately rough and uneven.</p>
N/A	20 - 30	<p>The pavement is in poor condition with moderate alligatoring and extensive severe cracking and distortion.</p> <p>The Ride Condition Rating is poor and the surface is very rough and uneven.</p>
N/A	0 - 20	<p>The pavement is in poor to very poor condition with extensive severe cracking, alligatoring and distortion.</p> <p>The Ride Condition Rating is very poor and the surface is very rough and uneven.</p>

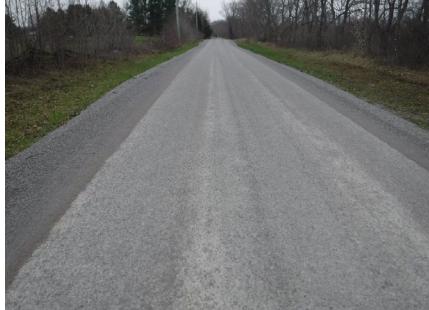
80 - 100	<p>Pavement is in excellent condition with just a few bumps or depressions from slight surface deformation. No surface defects such as streaking, potholes or cracking distresses.</p> <p>The Ride Condition Rating is very good.</p>

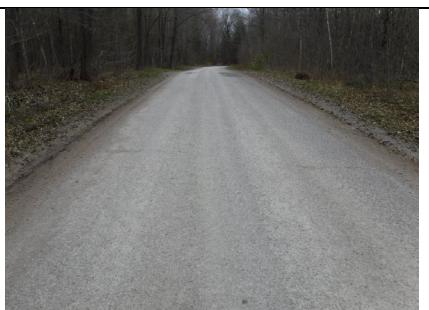
60 - 79	<p>Pavement is in good condition with just a few bumps or depressions from slight to moderate surface deformation. Intermittent slight to moderate surface defects and/or cracking distresses.</p> <p>The Ride Condition Rating is good.</p>

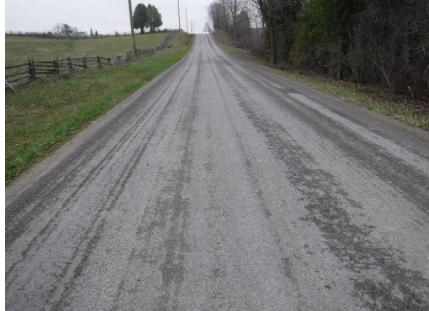
40 - 59	<p>Pavement is in fair condition with intermittent to frequent bumps or depressions from slight to moderate surface deformation. Intermittent to frequent moderate surface defects and/or cracking distresses.</p> <p>The Ride Condition Rating is fair.</p>

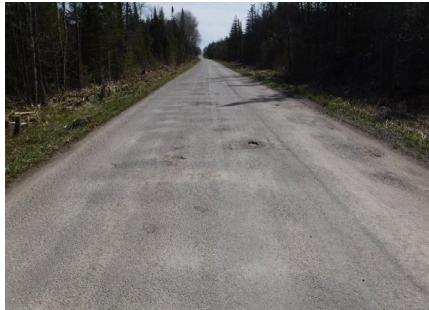
20 - 39	<p>Pavement is in poor condition with frequent bumps or depressions from moderate surface deformation. Frequent moderate to severe surface defects and/or cracking distresses. Localized slight to moderate alligatoring may be present indicating pavement structural failure.</p> <p>The Ride Condition Rating is poor.</p>

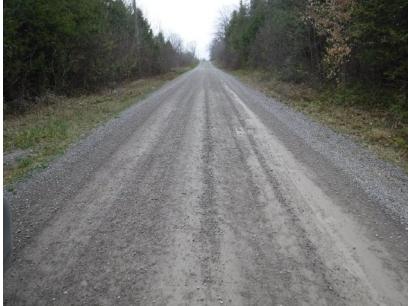
7 - 9	If it is possible to maintain the lesser of the Minimum Tolerable Average Operating Speed or the legal Speed Limit with only a noticeable amount of annoyance to the driver due to sway, vibration or steering effort, but with no noticeable feeling of hazard.
Photo not available	4 - 6	If maintaining even the lesser of the Minimum Tolerable Average Speed or the legal Speed Limit results in either a "tug-of-war" with a too-steep crown, or a feeling that the car is taking undue punishment.
N/A in Selwyn	1 - 3	If the surface irregularities are so severe that a driver will tend to reduce speed considerably, possibly even steering an irregular course, or if the crown is so steep as to be hazardous in winter.

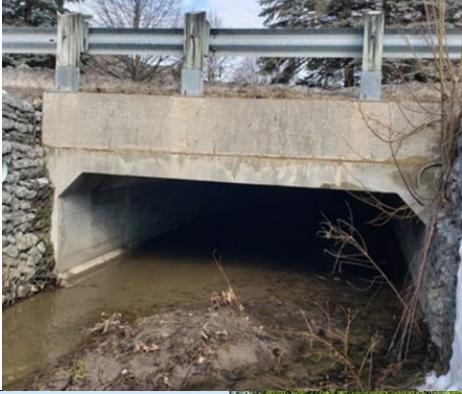
Structure Type	Structure Photo	Count	Average Age	Replacement Cost
Rectangular

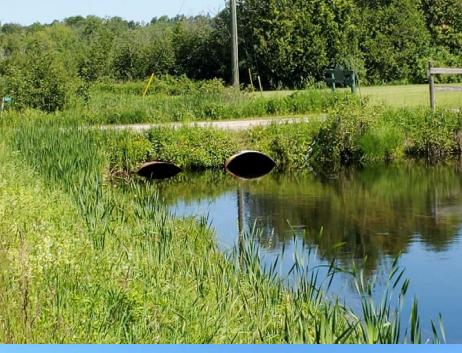
3	27	\$1,153,700
Twin Arch

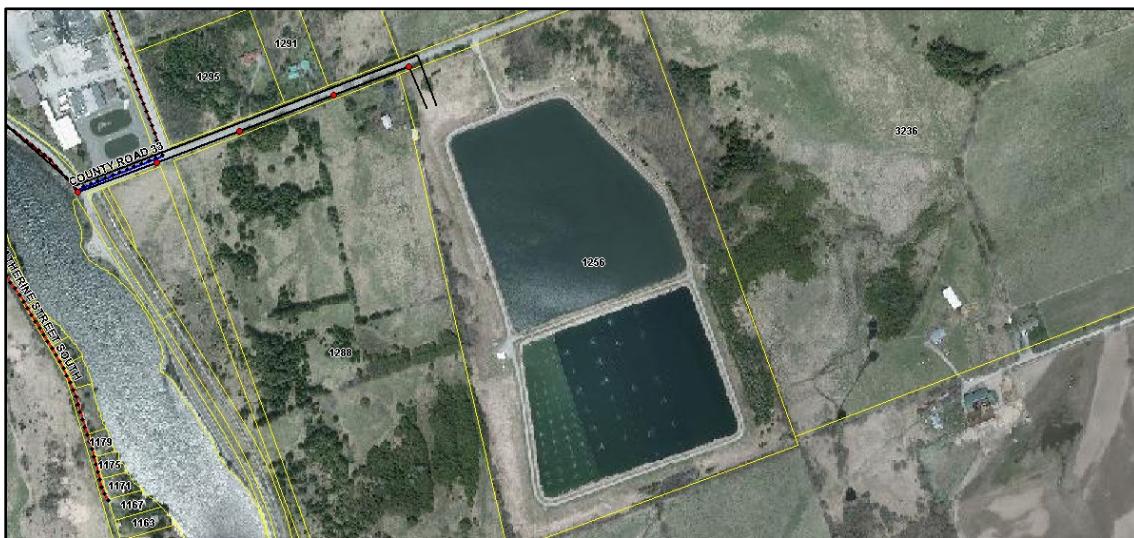
5.1.2 Lakefield Wastewater Treatment Plant (Lagoon)

The sewage treatment plant has a rated capacity of $2,300 \text{ m}^3$ per day, and is comprised of an aerated and sedimentation lagoon system and discharging to the Otonabee River. It consists of an aerated lagoon cell (south cell), approximate 275 m long x 212 m wide x 3.1 m deep, complete with a minimum 200 mm depth of clay liner along the cell bottom and side slopes and equipped with the following:

- Three (3) membrane baffles (to form four compartments) anchored to the side slopes by anchor posts and steel cables, and weighted with concrete anchor blocks, to create a serpentine (plug) flow of the effluent through the four (4) compartments, the first three (3) compartments utilized as an aeration zone and the last compartment as a settling zone;
- A 350 mm diameter air header pipe located within the dividing berm between the Cell No. 1 and 2, providing air supply to the three aeration compartments as follows:
 - Four (4) flexible aeration chains (100 mm dia. air hose supported by stainless steel cables complete with bio-fuser assembly comprising of hoses, downcomer fittings, manifolds and appurtenances, and twelve (12)

- submerged fine bubble diffusers per aeration chain) within the first aeration compartment;
- Two (2) flexible aeration chains (100 mm dia. air hose supported by stainless steel cables complete with bio-fuser assembly comprising of hoses, downcomer fittings, manifolds and appurtenances, and sixteen (16) submerged fine bubble diffusers per aeration chain) within each of the second and third aeration compartment;
- an inlet chamber into the first aeration compartment, and an outlet effluent chamber in the settling compartment to discharge effluent to Lagoon Cell No. 1 or to the disinfection facility.

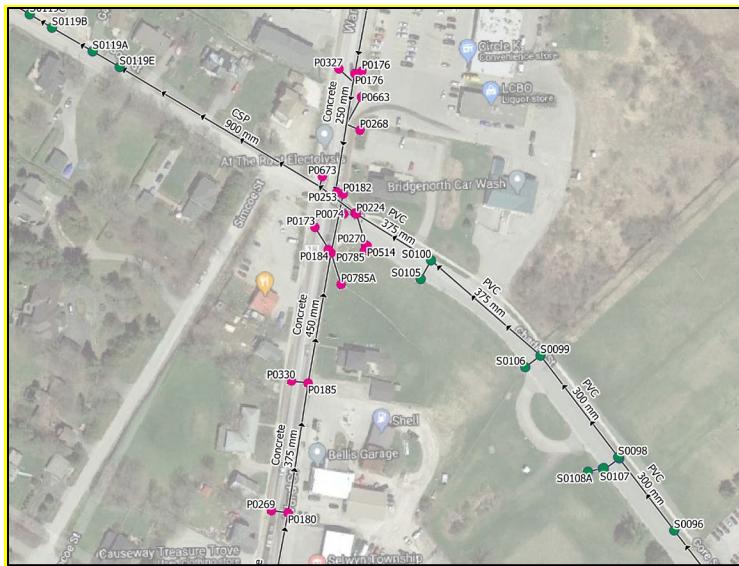
While typically associated with an urban road network, stormwater collection systems of varying sizes and composition are located throughout the rural and semi urban areas of the Township as well.

Given the function of this infrastructure, the Selwyn system is often linked with the County of Peterborough system, with each impacting the other.

Selwyn has over 17 kms. of storm sewers, 667 structures and 1 oil/grit separator structures.
