2024

Asset Management Plan

Township of Selwyn

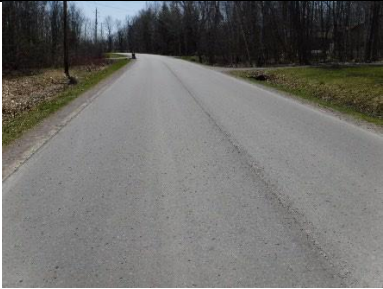
90 - 100	<p>Pavement is in excellent condition with few cracks.</p> <p>The Ride Condition Rating is excellent with few areas of very slight to slight distortion.</p>

Selwyn's HCB roads have PCI's ranging from 100 to 48.

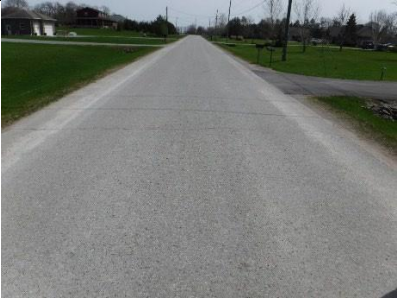
75 - 90	<p>The pavement is in good condition with frequent very slight or slight cracking.</p> <p>The Ride Condition Rating is good with a few slightly rough and uneven sections.</p>

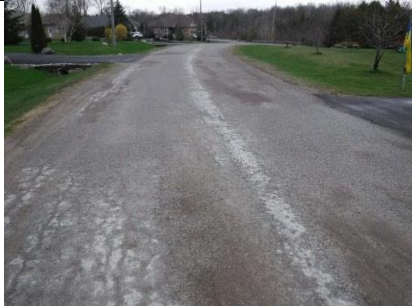
65 - 75	<p>The pavement is in fairly good condition with slight cracking, slight or very slight distortion and a few areas of slight alligatoring.</p> <p>The Ride Condition Rating is fairly good with intermittent rough and uneven sections.</p>

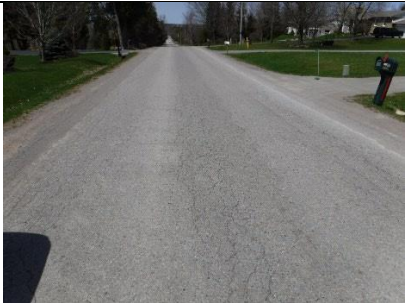
50 - 65	<p>The pavement is in fair condition with intermittent moderate and frequent slight cracking, and with intermittent slight or moderate alligatoring and distortion.</p> <p>The Ride Condition Rating is fair and the surface is slightly rough and uneven.</p>

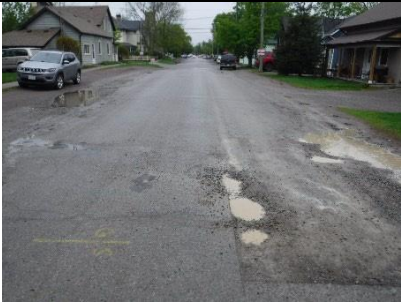
40 - 50	<p>The pavement is in poor to fair condition with frequent moderate cracking and distortion, and intermittent moderate alligating.</p> <p>The Ride Condition Rating is poor to fair and the surface is moderately rough and uneven.</p>
N/A	30 - 40	<p>The pavement is in poor to fair condition with frequent moderate alligating and extensive moderate cracking and distortion.</p> <p>The Ride Condition Rating is poor to fair and the surface is moderately rough and uneven.</p>
N/A	20 - 30	<p>The pavement is in poor condition with moderate alligating and extensive severe cracking and distortion.</p> <p>The Ride Condition Rating is poor and the surface is very rough and uneven.</p>
N/A	0 - 20	<p>The pavement is in poor to very poor condition with extensive severe cracking, alligating and distortion.</p> <p>The Ride Condition Rating is very poor and the surface is very rough and uneven.</p>

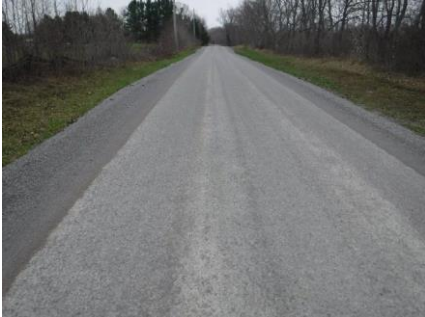
80 - 100	Pavement is in excellent condition with just a few bumps or depressions from slight surface deformation. No surface defects such as streaking, potholes or cracking distresses. The Ride Condition Rating is very good.

Selwyn's LCB roads have PCI's ranging from 91 to 33.

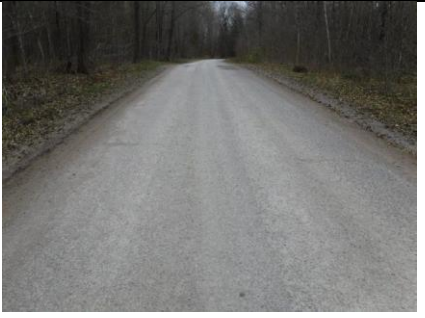
60 - 79	Pavement is in good condition with just a few bumps or depressions from slight to moderate surface deformation. Intermittent slight to moderate surface defects and/or cracking distresses. The Ride Condition Rating is good.

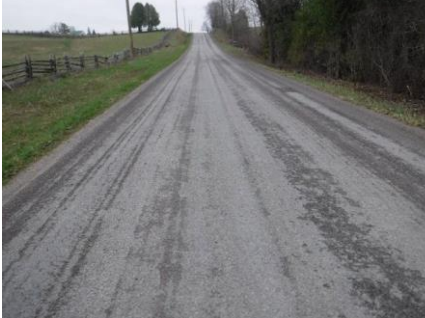
40 - 59	Pavement is in fair condition with intermittent to frequent bumps or depressions from slight to moderate surface deformation. Intermittent to frequent moderate surface defects and/or cracking distresses. The Ride Condition Rating is fair.

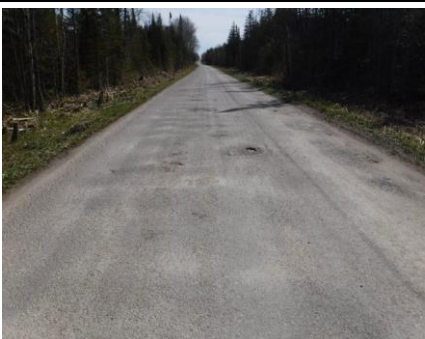
20 - 39	Pavement is in poor condition with frequent bumps or depressions from moderate surface deformation. Frequent moderate to severe surface defects and/or cracking distresses. Localized slight to moderate alligating may be present indicating pavement structural failure. The Ride Condition Rating is poor.

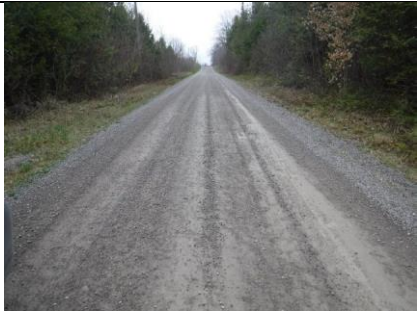
7 - 9	If it is possible to maintain the lesser of the Minimum Tolerable Average Operating Speed or the legal Speed Limit with only a noticeable amount of annoyance to the driver due to sway, vibration or steering effort, but with no noticeable feeling of hazard.
Photo not available	4 - 6	If maintaining even the lesser of the Minimum Tolerable Average Speed or the legal Speed Limit results in either a “tug-of-war” with a too-steep crown, or a feeling that the car is taking undue punishment.
N/A in Selwyn	1 - 3	If the surface irregularities are so severe that a driver will tend to reduce speed considerably, possibly even steering an irregular course, or if the crown is too steep as to be hazardous in winter.

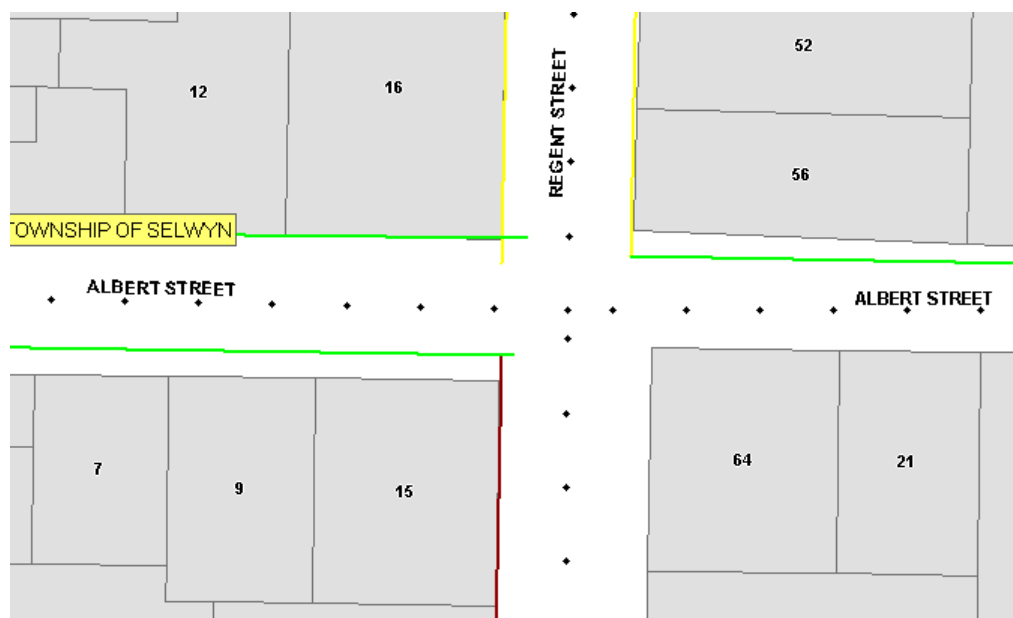
The following excerpt provides an example of the sidewalk network with the condition rating layer turned on. Colour coding ties in with the pie chart above.

The Township uses an Excel sheet based on road segments to collect data and track asset attributes. The Road Segments ID is the primary data source for storage and display on GIS, allowing the user to display a map of the subject area and then add or remove specific layers that display various data sets.

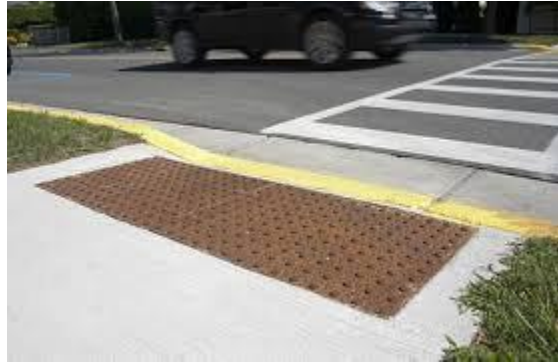
In terms of AODA compliance, almost all sidewalks were lacking tactile walking surface indicators (TWSI) at the bottom of curb ramps. TWSI should be installed on all new and reconstructed curb cuts/depressed curbs.

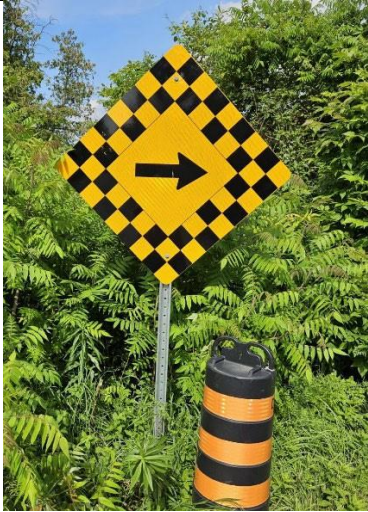
Good	Overall condition is very good. The retro-reflectivity is graded as a Pass.

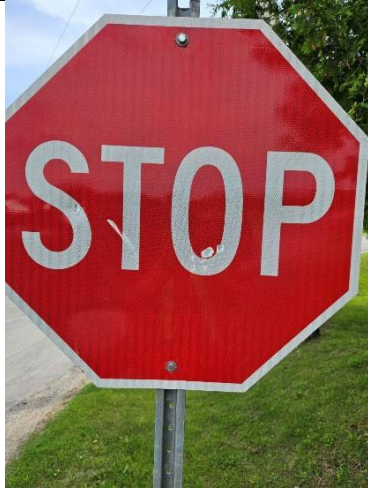
Fair	Overall condition is good, with some scratches and missing paint. The retro-reflectivity is graded as a Pass.

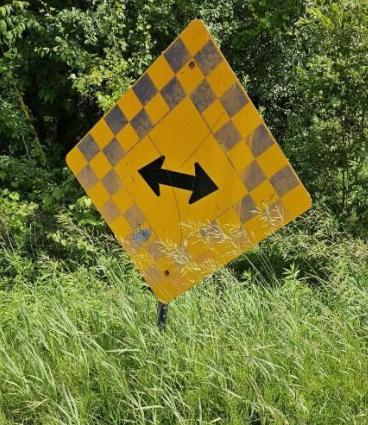
Poor	Overall condition is poor and vertical alignment is not good. The retro-reflectivity is graded as a Fail.

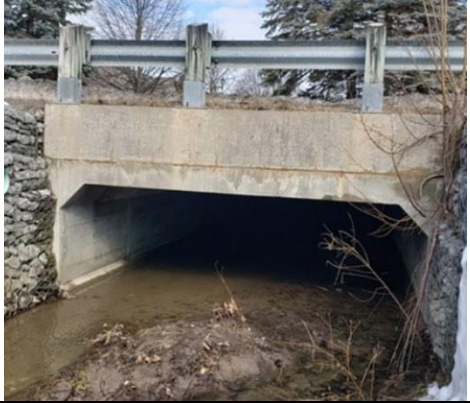
Structure Type	Structure Photo	Count	Average Age	Replacement Cost
Rectangular

3	27	\$1,153,700
Twin Arch

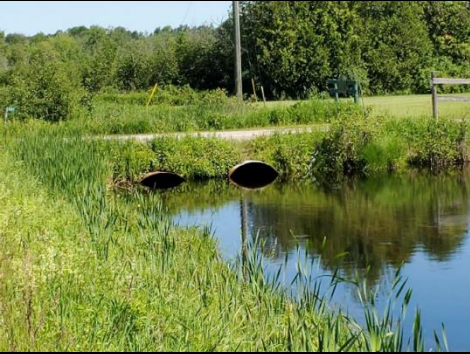
2	32	\$570,500
Arch

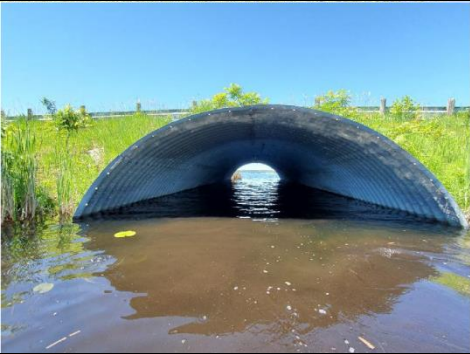
2	40	\$502,300
Total		7	32	\$2,456,370

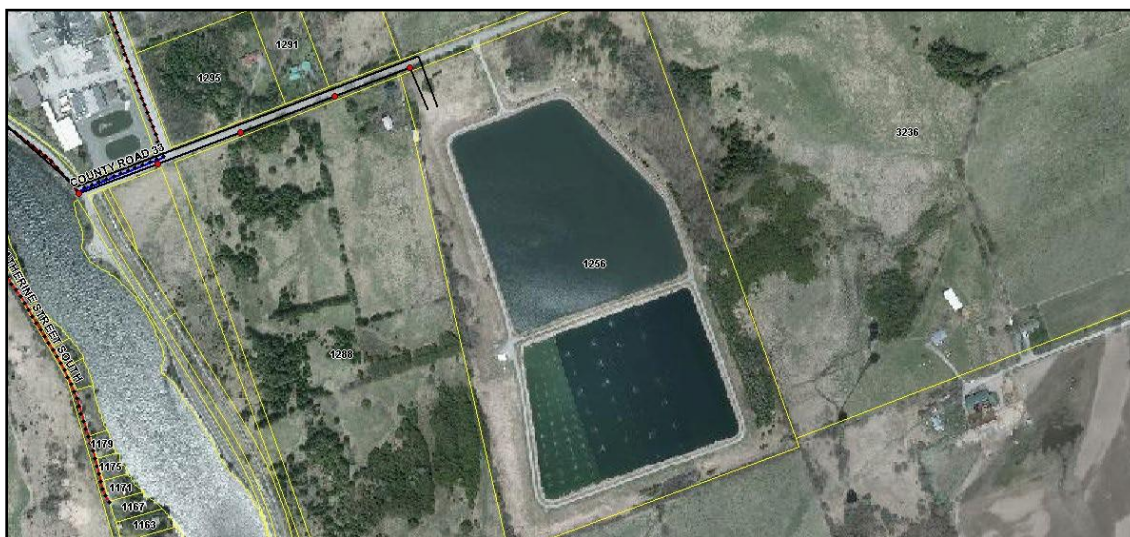
5.1.2 Lakefield Wastewater Treatment Plant (Lagoon)

The sewage treatment plant has a rated capacity of 2,300 m³ per day, and is comprised of an aerated and sedimentation lagoon system and discharging to the Otonabee River. It consists of an aerated lagoon cell (south cell), approximate 275 m long x 212 m wide x 3.1 m deep, complete with a minimum 200 mm depth of clay liner along the cell bottom and side slopes and equipped with the following:

- Three (3) membrane baffles (to form four compartments) anchored to the side slopes by anchor posts and steel cables, and weighted with concrete anchor blocks, to create a serpentine (plug) flow of the effluent through the four (4) compartments, the first three (3) compartments utilized as an aeration zone and the last compartment as a settling zone;
- A 350 mm diameter air header pipe located within the dividing berm between the Cell No. 1 and 2, providing air supply to the three aeration compartments as follows:
 - Four (4) flexible aeration chains (100 mm dia. air hose supported by stainless steel cables complete with bio-fuser assembly comprising of hoses, downcomer fittings, manifolds and appurtenances, and twelve (12)

- submerged fine bubble diffusers per aeration chain) within the first aeration compartment;
- Two (2) flexible aeration chains (100 mm dia. air hose supported by stainless steel cables complete with bio-fuser assembly comprising of hoses, downcomer fittings, manifolds and appurtenances, and sixteen (16) submerged fine bubble diffusers per aeration chain) within each of the second and third aeration compartment;
- an inlet chamber into the first aeration compartment, and an outlet effluent chamber in the settling compartment to discharge effluent to Lagoon Cell No. 1 or to the disinfection facility.
